MODEL 540 MAIN ROTOR BLADE FATIGUE TEST

Arthur J. Gustafson, et al

Army Air Mobility Research and
Development Laboratory
Fort Eustis, Virginia

January 1976

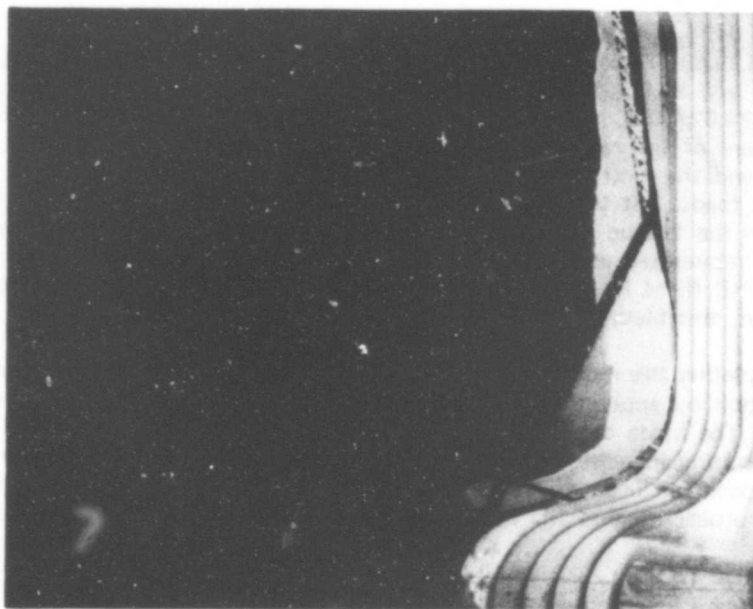
At 9,891,000 fatigue cycles, a portion of the trailing-edge box and the spar closure at station 212 failed in fatigue. Figures 13 and 14 indicate the failure in the upper and lower surface of the blade respectively. This failure was induced by the end fitting and the fact that all loads outboard of station 110 (which is the center of the test section) were higher than the fatigue spectrum loads. The failure was not a result of the spar-to-spar closure debond. No damage was experienced by the spar, and the blade was capable of reacting the static and alternating loads. Consequently, the trailing-edge box was patched as shown in Figure 15, and an additional 40,000 fatigue cycles were run to confirm that the applied loads in the region of the debond were equal to the loads prior to failure. The loads inboard of station 160 were found to be the same as before the failure at station 212. The test was terminated on this blade, as further testing would have resulted in failure at the tip grip.

Figure 13. View of trailing-edge box failure near the tip, top surface, test specimen No. 1.

Figure 14. View of trailing-edge box failure near the tip, bottom surface, test specimen No. 1.

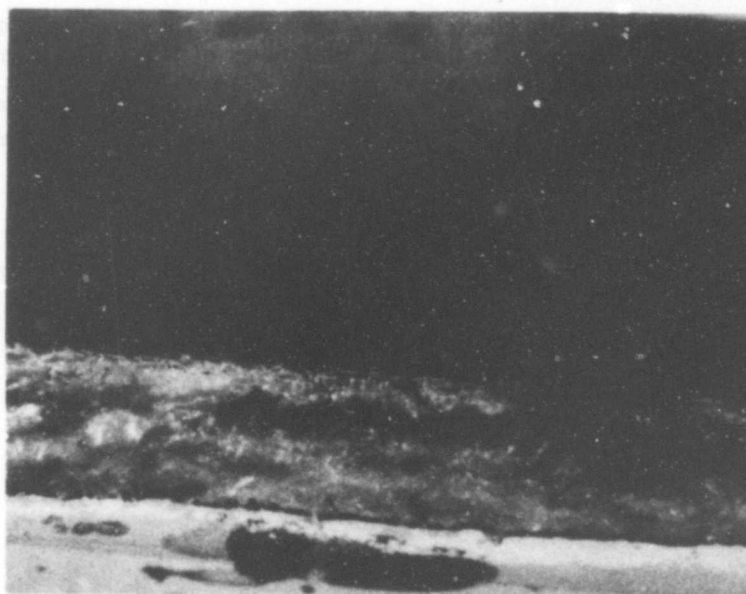
Figures 21 through 23 indicate cracks as they can be seen through a borescope. The first two figures correspond to cracks in the outermost fibers of the excess adhesive adjacent to a sound bond. The last figure corresponds to an all-the-way-through crack. It is obvious that it is almost impossible to identify the "real" crack and that the use of an alternate inspection technique is mandatory. Ultrasonic through-transmission was used to detect the extent of the crack.

Figure 21. Crack existing on the bondline excess adhesive viewed through a borescope.

Figure 22. Crack existing on the bondline excess adhesive viewed through a borescope.

Figure 23. All-the-way-through crack viewed through a borescope.
